Article

# Monitoring Cultural Heritage Sites with Advanced Multi-Temporal InSAR Technique: The Case Study of the Summer Palace

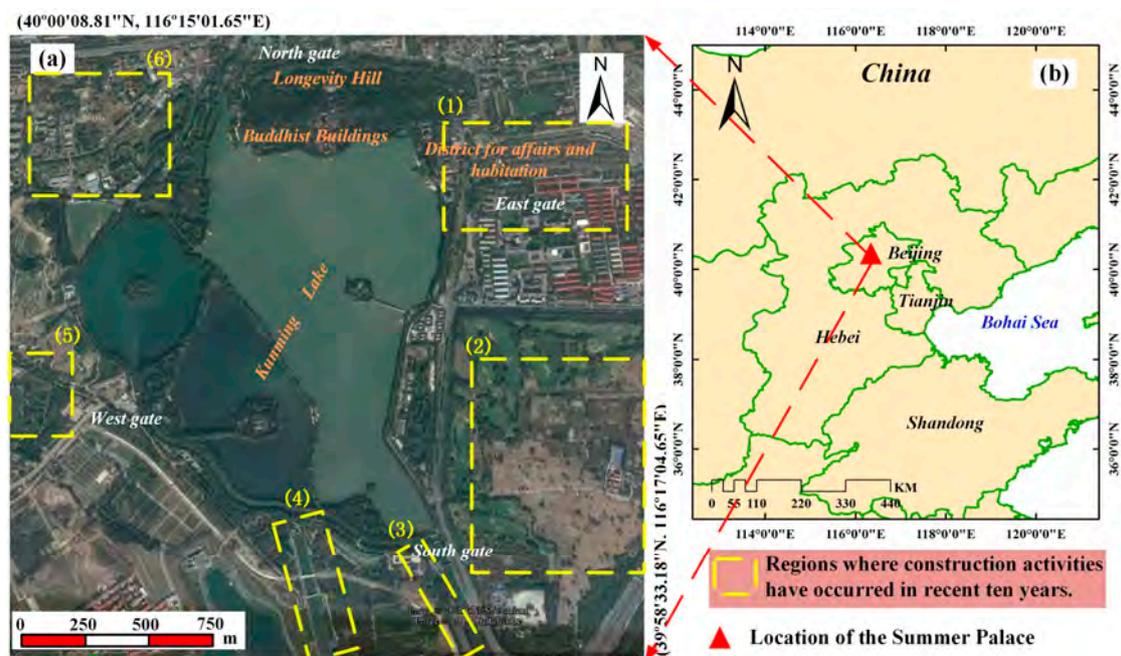
**Figure 1.** (a) Summer Palace study area (courtesy of Google Earth) with construction zones indicated by yellow dashed lines; and (b) location of the Summer Palace.

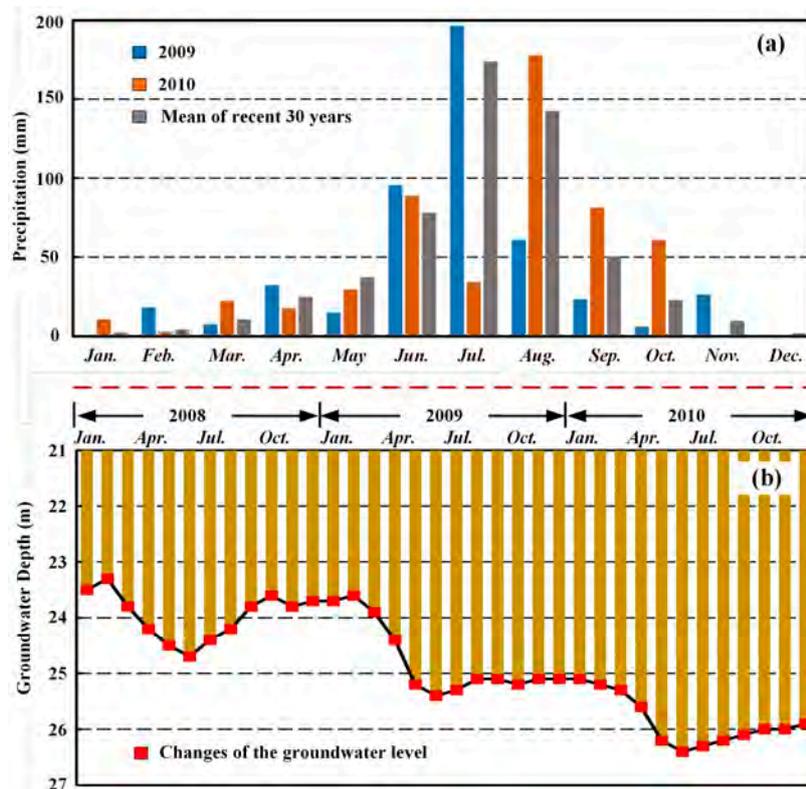
**Figure 2.** (a) Monthly precipitations of 2009 and 2010 and the mean values calculated from the last 30 years; and (b) groundwater variations of Beijing City in the period of 2008–2010.

In this study, the changes of the heritage site, particularly the motion anomalies, were assessed by radar interferometry. Twenty scenes of x-band (radar frequency of 9.6 GHz) COSMO-SkyMed SLC images were used for the analysis. They were acquired along descending orbits with the “Stripmap Himage” and “HH polarization” mode, spanning from January 2009 to October 2010. The center incidence angle was approximately  $20.2^\circ$  and the pixel spacing is 0.769 m and 2.266 m in range and azimuth direction, respectively. Precipitation for 2009–2010 and groundwater data for 2008–2010 were collected from Beijing Water Authority. During those two years, Beijing experienced a period of drought with the annual precipitation ranging between 480 and 524 mm, well below long-term average value of 558 mm over the last 30 years (see Figure 2a). Furthermore, approximately 80% of the rainfall during 2009–2010 occurred in the summer, from June to September. Figure 2b illustrates the changes in groundwater level (averaged values from boreholes in downtown locations) of Beijing City during the period of 2008–2010. A declining trend can be observed with an average value of approximately 2.7 m. As a man-managed reservoir, Kunming Lake generally stores water in spring for the tourism and draws off a certain volume for security purposes before the freezing season, resulting in the water-level rises in summer and falls-off in winter. In the observation period of 2009–2010, the lake level descended more than half a meter during summer (reported by administrators), coinciding with the decline trend of the groundwater level (see Figure 2b).

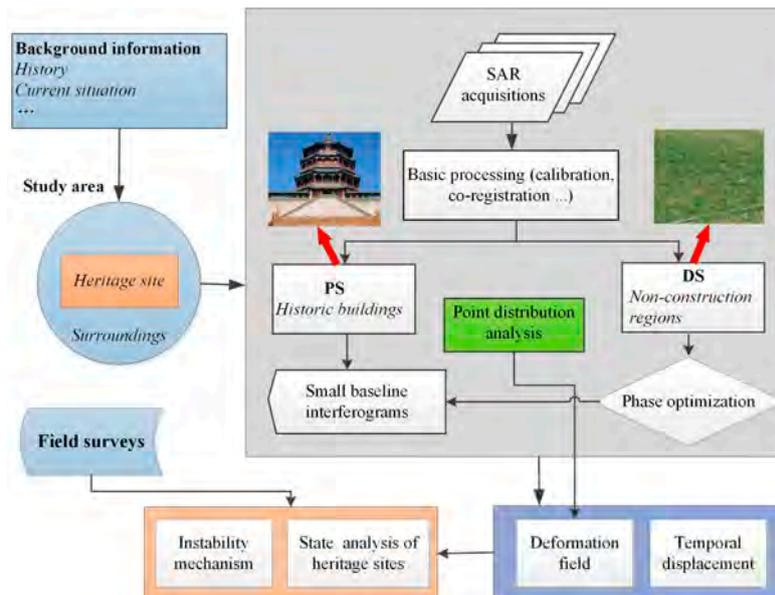
**Figure 3.** Flow chart of the data processing and interpretation for the monitoring of heritage sites using the advanced Multi-Temporal Interferometric Synthetic Aperture Radar (MTInSAR) approach.

Monitoring the deformation of cultural heritage sites by advanced MTInSAR approach proposed herein is a complex task. The entire data processing and interpretation flow is shown in Figure 3. A comprehensive background investigation is recommended as a first step to obtain detailed data and knowledge of the characteristics of the site with regard to landscape, ground features, spatial scale, and geometric and material properties [3]. These measures facilitate the choice of hot spots, the adoption of efficient data processing techniques [11] and the identification of monuments. In general, there is a close link between regional surface displacements and the monument structural instabilities. As for the Summer Palace, historic architectures, ruins, slopes of Longevity Hill and the surrounding surface were systematically monitored.

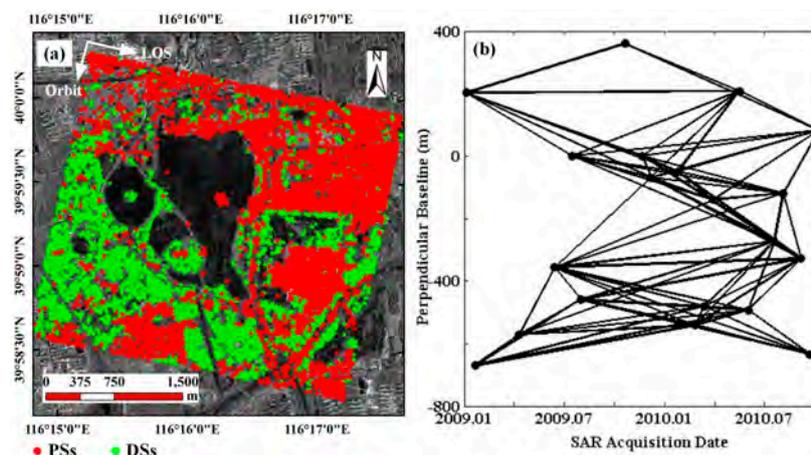
**Figure 4.** (a) Distribution of Persistent Scatterers (PSs) and Distributed Scatterers (DSs) in the Summer Palace and its surroundings; and (b) interferograms with spatial and temporal baselines (circles indicate SAR acquisitions).

Based on the candidate points, the procedure of SBAS technique was applied to estimate the unknown parameters (e.g., deformation rates and residual heights) in order to mitigate the constraint of SAR image numbers as well as to enhance the interferogram coherence. Eighty-three differential interferograms with small orbital and temporal baselines (see Figure 4b) were derived after removing

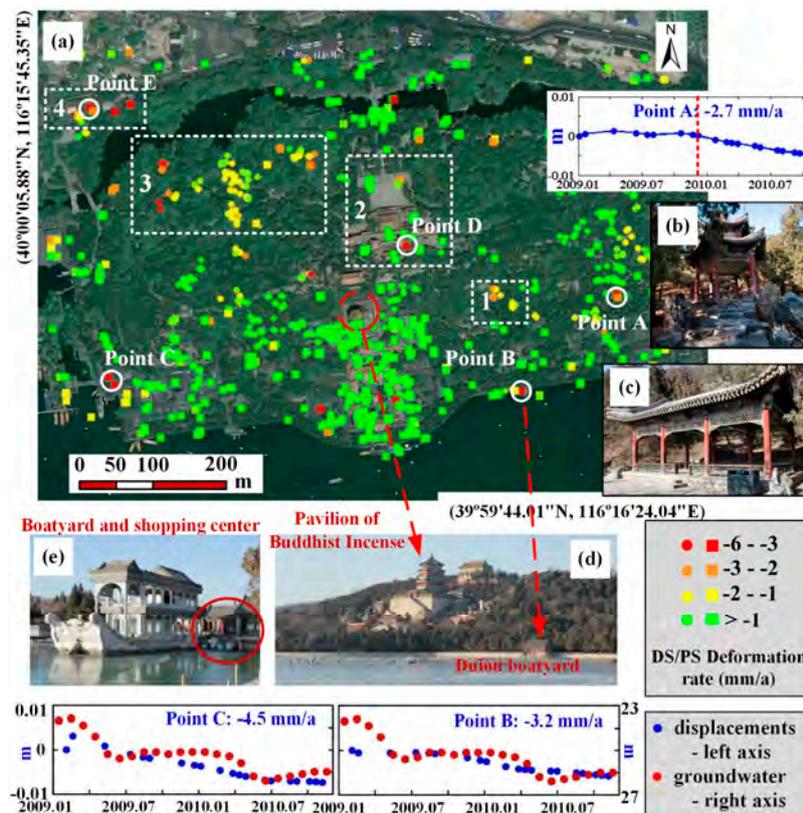
**Figure 5.** (a) Map of deformation rates of the Longevity Hill superimposed on the Google Earth image. Four typical regions (from Region 1 to Region 4) and five points (A–E) with significant motions are shown; (b–e) Photographs of Point A, Region 1, and Points B and C obtained during field campaigns, respectively. The three graphs illustrate displacement evolution (blue dots) of Points A–C; the red dashed line in the evolution of Point A was used to mark the starting time of subsidence. Groundwater data (red dots) were used to validate the motion evolutions of Points B and C.

Protective measures and/or consolidations have been periodically introduced, particularly for essential monuments; for example, iron sticks were installed to fasten wooden structures (a common countermeasure in the site). Deformation map (see Figure 5a) demonstrates that the entire Longevity Hill was relatively stable, with LOS rates ranging from  $-6.0$  to  $1.0$  mm/a. However, a few regional and individual instabilities were detected. Point A, with the deformation rate of  $-2.7$  mm/a, refers to the Hanxin pavilion located in the eastern hillside (see Figure 5b). The displacement evolution showed that the pavilion was stable until the end of 2009, and then subsided at a constant rate. Compared to the stable DSs measurements of the neighborhood, it implied that the instability was attributable solely to the structural degradation of the pavilion rather than its surrounding surface. Region 1 is located at the halfway down the hill, containing a pavilion named Chongcui (see Figure 5c) with a brick floor

that is favorable for the extraction of DSs. The deformation rate of  $-2.6$  mm/a reflected instabilities caused by the slope sliding in steep terrain. Point B belongs to a structure named Duiou (see Figure 5d), which used to be a waiting room but has now been converted into a boatyard and shop. Deformation results, with the deformation rate up to  $-3.2$  mm/a, indicated that it was unstable. Point C is in the region occupied by several shops and a boatyard (see Figure 5e), indicated a distinct subsidence with rates up to  $-4.5$  mm/a. Dense tourism flow, which would impose pressures on structures (e.g., overweight and destructive activities), combined with the water-level change explains the motion anomaly. Groundwater data were used to validate the evolution of Points B and C, indicating a consistent trend among the two observations. Another factor responsible for the instabilities could be the protracted maintenance or protection activities implemented in the area.

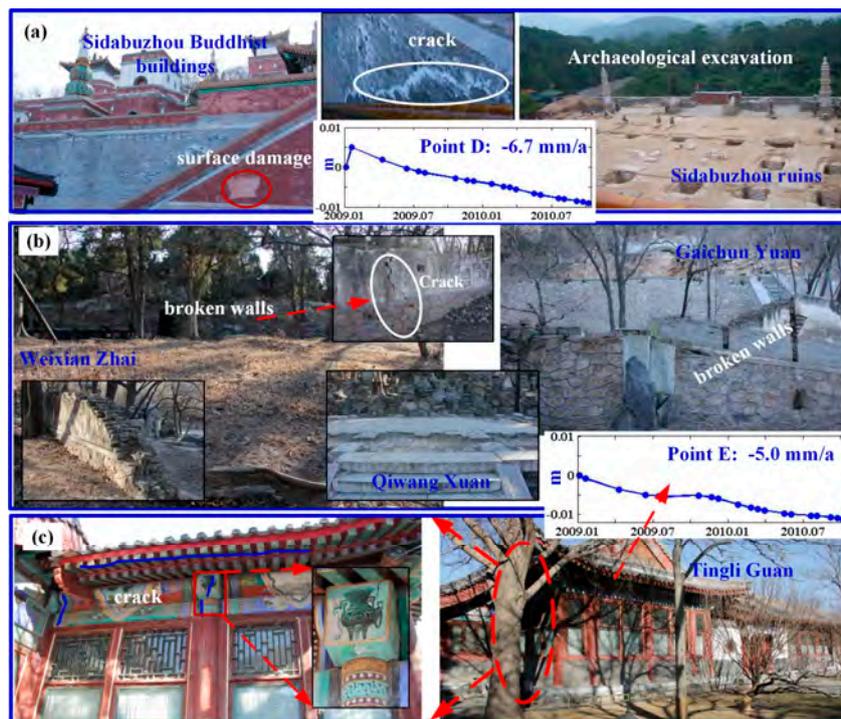
**Figure 6.** Photographs of Regions 2–4 marked in Figure 5a: (a) Region 2; (b) Region 3; and (c) Region 4. Displacement evolution of Points D and E (see Figure 5a for their locations) are illustrated by two sub-graphs.

At the north side of the Longevity Hill, three regions (Regions 2–4) were selected for analysis, and their corresponding photographs are illustrated in Figure 6. MTInSAR-derived results indicated that they were suffering from subsidence in the mm–cm level. Region 2 belongs to Sidabuzhou with several Buddhist buildings in the south and ruins in the north (see Figure 6a). Monuments here tended to be vulnerable over hundreds of years, validated by the surface damages or cracks on ancient walls. Point D indicated the instability of one historical building with a deformation rate of  $-6.7$  mm/a. Archaeological excavations were carried out in ruins since 2010 when SAR images started to be acquired, resulting in the extraction of sparse DSs. Several PSs with deformation rates over  $-2.0$  mm/a caused by the disturbance from human activities (e.g., archaeological excavations) were identified.

Region 3 refers to three residual ruins covered by dense woods (see Figure 6b). Nobody would notice them if no DSs were extracted for those locations. The combined deterioration due to human activities and natural decay contributed to the instabilities in these Regions. For instance, nothing is left nowadays on Gaichun Yuan (used to be a beautiful garden located along the steep hillside) except for broken walls and residual pillars. DSs and PSs, with the maximum deformation rate of  $-3.9$  mm/a, were identified due to the strong signal echo from wall remains. The site in the middle (WeixianZhai) used to be a school palace of Emperor Qianlong. At present, only collapsed walls and residual pillars remain. Compared with the previous site, this region is more stable due to the flat terrain and deformation rate was  $-1.5$  mm/a on DS points. The west site refers to Qiwang Xuan, a garden connecting the Longevity Hill to the boatyard. As seen in the photograph, it is clear that the floor with a steep terrain was damaged due to subsidence with values up to  $-4.3$  mm/a. In Region 4, there are a group of houses named Tingli Guan (see Figure 6c), which used to be an imperial opera hall but today it is a famous restaurant. Instabilities of wood structures (e.g., cracks) could be observed on the walls and correspond to PSs with deformation rates up to  $-5.0$  mm/a (Point E).

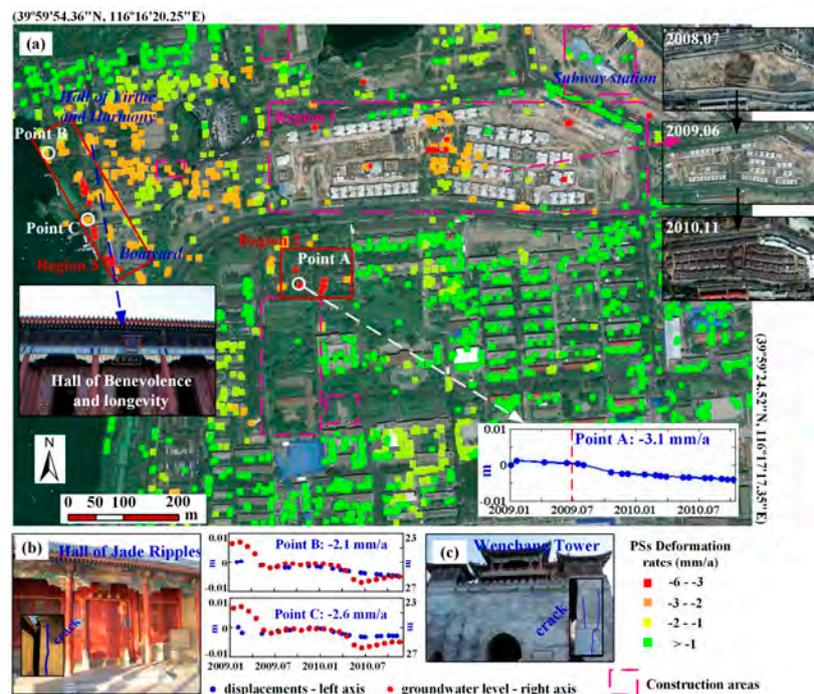
**Figure 7.** (a) Map of deformation rates in the East Gate region superimposed on the Google Earth image acquired in June 2009. Constructions during 2009–2010 and their impacted neighborhoods are marked as pink and red dashed-boxes; (b,c) Photographs of Points B and C, respectively. The graphs illustrate the displacement evolution (blue dots) of Points A–C. The red dashed line in the evolution of Point A was used to mark the starting time of the construction activity in the south. Groundwater data (red dots) were used to validate the displacement evolution of Points B and C.

Figure 7 illustrates the regional subsidence of MTInSAR results. Region 1 refers to a stretch of residential quarters built in the period from 2008 to 2011. The drastic surface changes here resulted in the absence of PSs except for the location of the central subzone where construction was completed before the acquisitions of SAR images. PSs in this region exhibited a significant subsidence trend with deformation rates ranging from  $-2.0$  to  $-4.0$  mm/a. In Region 2, a group of bungalow-type accommodations were identified as PSs. Instabilities were detected, such as in Point A with a deformation rate of  $-3.1$  mm/a. A subsidence event occurred in the period from June to September 2009, immediately after the construction in the south, placing the responsibility on construction behavior for instabilities in Region 2. Thorough maintenance work was launched since 2014 for the conservation of relics. All historic remains around the East Gate of the Summer Palace, including the Hall of Virtue and Harmony, Hall of Benevolence and Longevity and Wenchang Yard, indicate a moderate subsidence with LOS deformation rates ranging from  $-3.0$  to  $-2.0$  mm/a. Renovation and/or consolidation countermeasures are urgently needed. Motion sensors have been installed by administrators for the monitoring of destructive motions. Measurements of them confirmed the instability phenomenon in this area.

Significant subsidence was mainly detected on the artifacts (including halls, shopping centers, a boatyard and tower) along the Kunming Lakeside of Region 3. Point B refers to the Hall of Jade Ripples (see Figure 7b). It used to be the emperor's living quarters (the emperor of Guangxu was once imprisoned here). The corresponding deformations, with a rate of  $-2.1$  mm/a, were modulated by the fluctuation associated with the seasonal variation of the water-level of Kunming Lake. A long crack on the wall was observed during field investigations. Deformation rates of over  $-3.0$  mm/a were detected on shopping facilities, demonstrated by consecutive PSs in Region 3. Point C is located on the two-story Wenchang Tower (see Figure 7c). Wall cracks are clearly visible although they have been whitewashed several times. Evolution of Points B and C indicates a consistent trend compared with

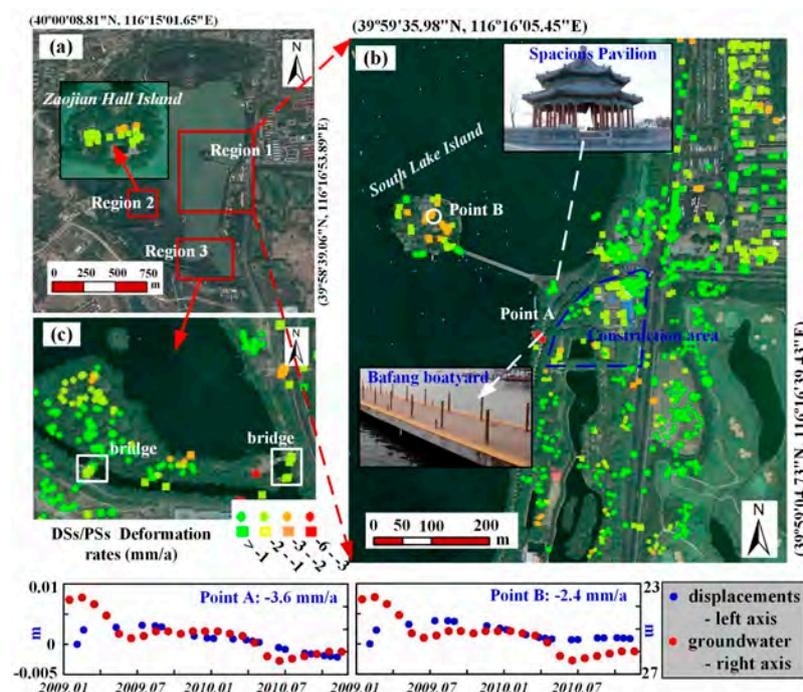
**Figure 8.** (a) Google Earth map of the study site and the deformation map of Zaojian Hall Island; (b) map of deformation rates in Region 1 and the displacement time series of Points A and B; and (c) map of deformation rates in Region 3. The graphs illustrate displacement evolution of Points A and B (blue dots) together with the change of groundwater level (red dots).

Sinking was also observed in the island of Zaojian Hall (used to be the place for reading, writing and painting), as illustrated by the Region 2 in Figure 8a and is attributable to the decline of groundwater level during 2009–2010 (see Figure 2b). In the vicinity of the South Gate (Region 3), plenty of DSs (open area with trees) and PSs (man-made structures) were extracted; unstable trends with the maximum rate of  $-3.3$  mm/a, particularly for features associated with the bridges (Figure 8c), were observed.

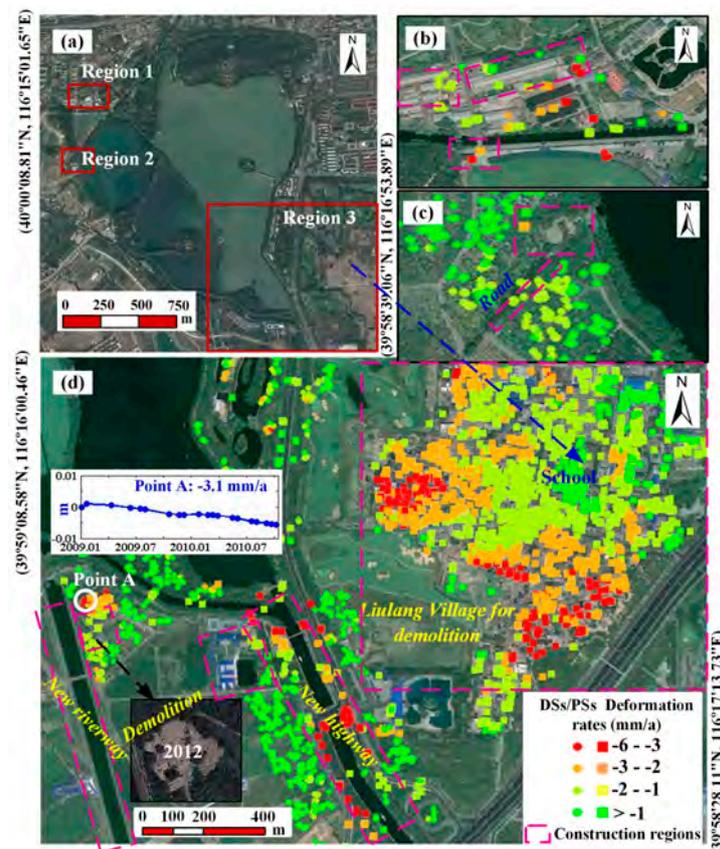
**Figure 9.** (a) Google Earth map of the subzone; (b) map of deformation rates in Region 1; (c) map of deformation rates in Region 2; and (d) map of deformation rates in Region 3. Displacement time series of Points A and B are also shown. Regions under construction are marked by pink dashed boxes.

The surrounding landscape of the Summer Palace had experienced significant changes since 2009. Intense human activities within red-rectangles (see Figure 9a) threatened the safeguarding of precious heritage features. In this section, three representative regions were selected for deformation analysis. Region 1 refers to the residential district where at least three sub-zones were under construction or demolition (see Figure 9b) in 2009, initiating instabilities among neighborhood buildings; e.g., Point A with the rate of  $-3.6$  mm/a. Region 2 shows a sparsely vegetated area with several houses nearby the lakeside (see Figure 9c). This area used to be a farmland but has been redeveloped as a park. A regional surface subsidence was detected by DSs ( $-2.0$ ~ $-1.0$  mm/a) due to the construction of a road. Region 3 experienced significant changes (see Figure 9d). First, a village named Liulang was almost completely demolished due to urbanization except for a primary school at the southeast of Kunming Lake. PSs were identified on the houses before the demolition (started in 2011, immediately after the completion of SAR data acquisitions). Deformation results during 2009–2010 indicate that this residential site was unstable particularly along the peripheries (with the maximum subsidence of  $-3.0$  mm/a) due to preparations for demolitions. Second, a highway and a factory were built in 2008 and 2009, respectively, in the south side of the South Gate. Deformation results indicate that the highway was subsiding, with a maximum rate of over  $-4.0$  mm/a. In contrast, a steady condition was observed along the roadside using the DSs-derived deformations. Third, as one component of the “Water Diversion Project”, a riverway was constructed during 2006–2009. All buildings surrounding Point A had been demolished before 2012 (see the historic Google Earth images in Figure 9d). Point A, with a LOS deformation rate of  $-3.1$  mm/a, indicated the instabilities of this region caused by the construction and demolition activities.
